Texture Modification of the Shuttle Landing Facility Runway at Kennedy Space Center

*Robert H. Daugherty and Thomas J. Yager
Langley Research Center • Hampton, Virginia*

Summary

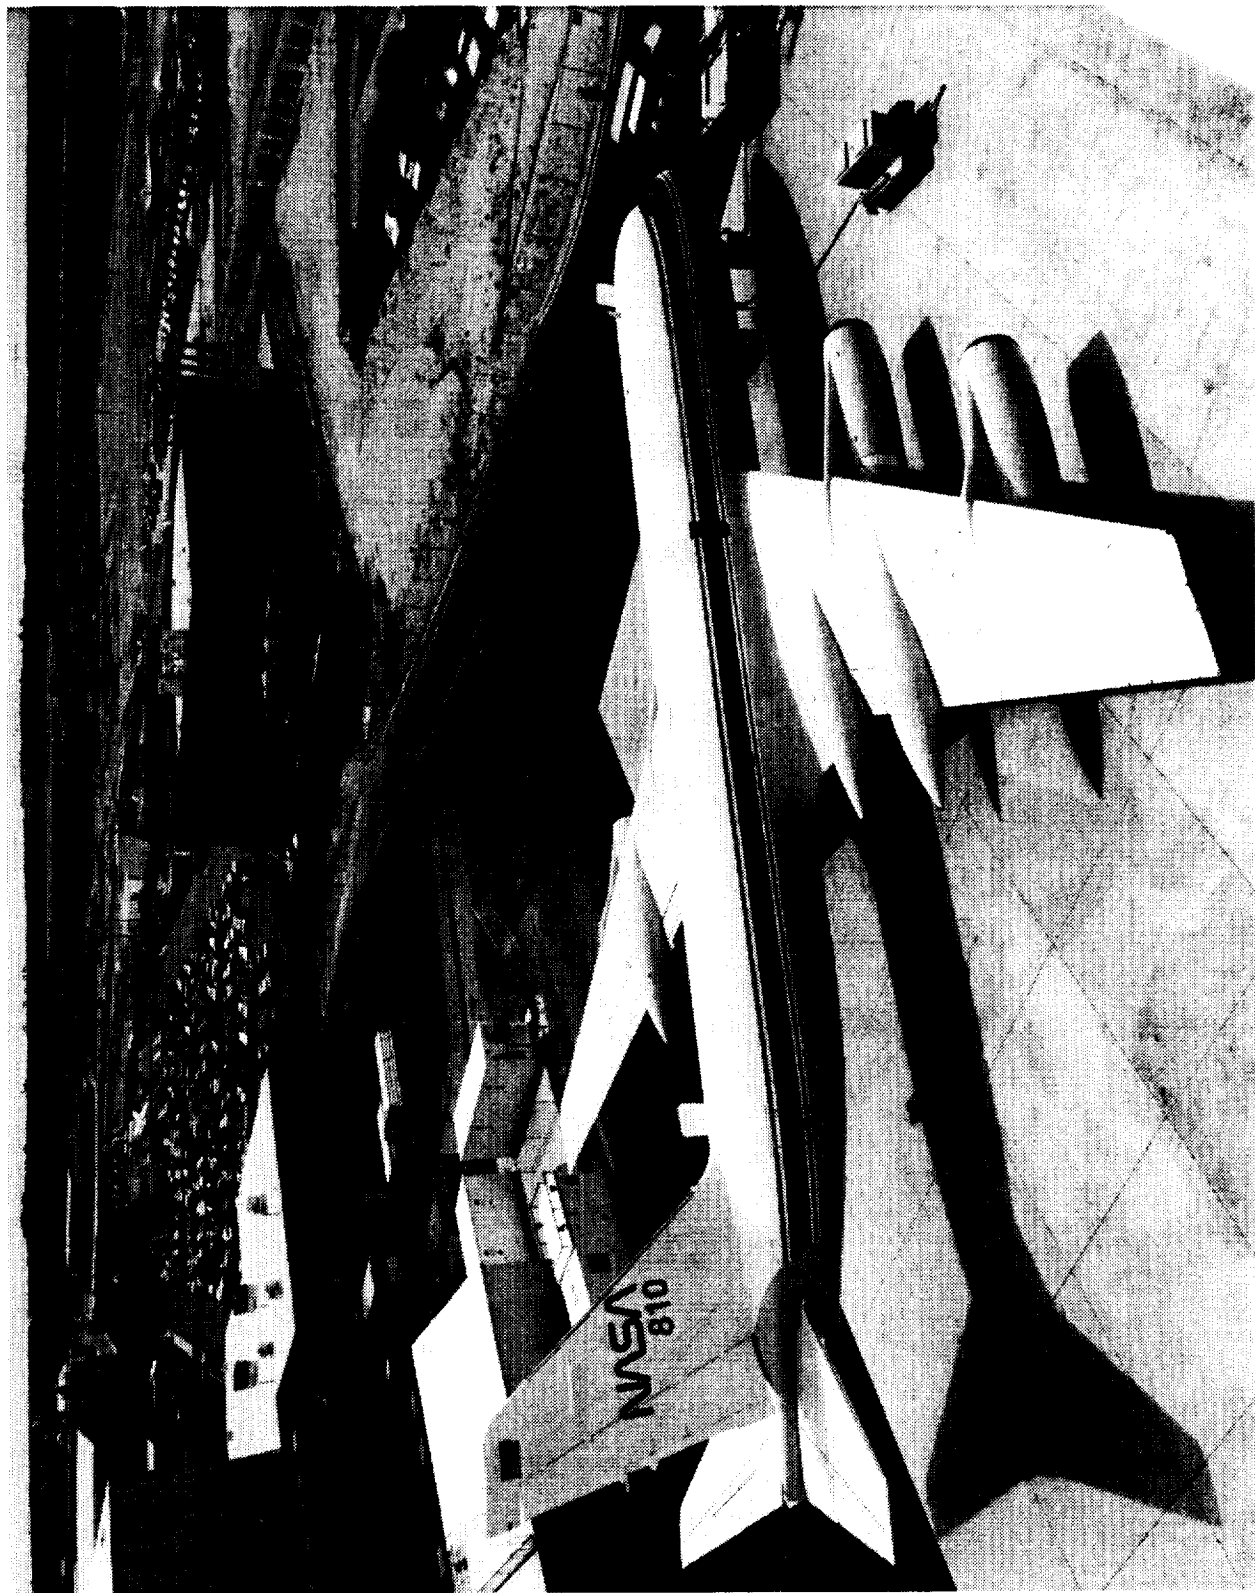
Figure 3. Landing Systems Research Aircraft (LSRA).

Landing Systems Research Aircraft (LSRA). In 1989 NASA designed a test facility capable of simulating full-scale Orbiter landing conditions. The facility consists of a modified Convair 990 aircraft and is known as

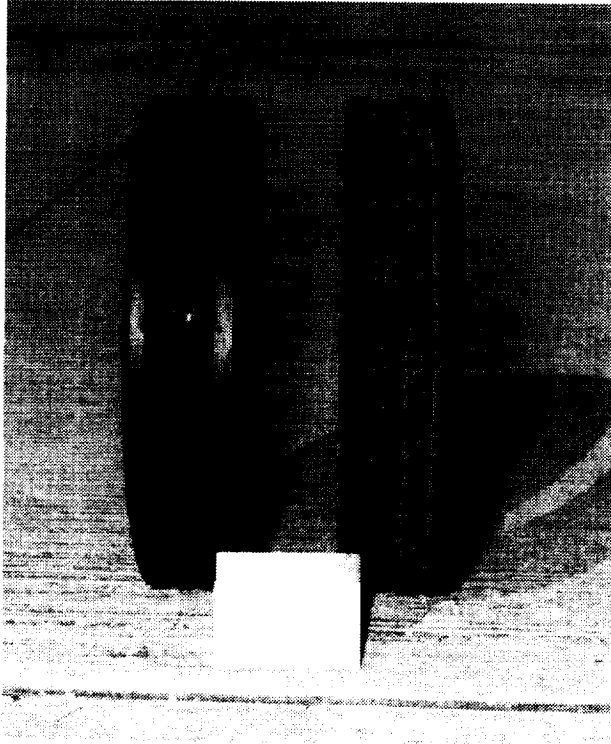
(a) ITTV test tires.

ITTV tests. The test tires used on the test fixture of the ITTV were 20×4.4 bias-ply Type VII aircraft tires with a ply-rating of 14 and a 3-groove tread design; they are similar to those found on the main gear of a T-38 aircraft. A new and a worn ITTV test tire are shown in figure 6(a). The rated load and pressure of the tire are 6000 lb and 265 psi, respectively. Because it was desirable for wear testing to have the test tire inflated to the actual Orbiter tire pressure, the ITTV test tires were inflated to 350 psi. The tires were mounted on standard aircraft wheels according to accepted buildup procedures. A new tire was used for each surface tested.

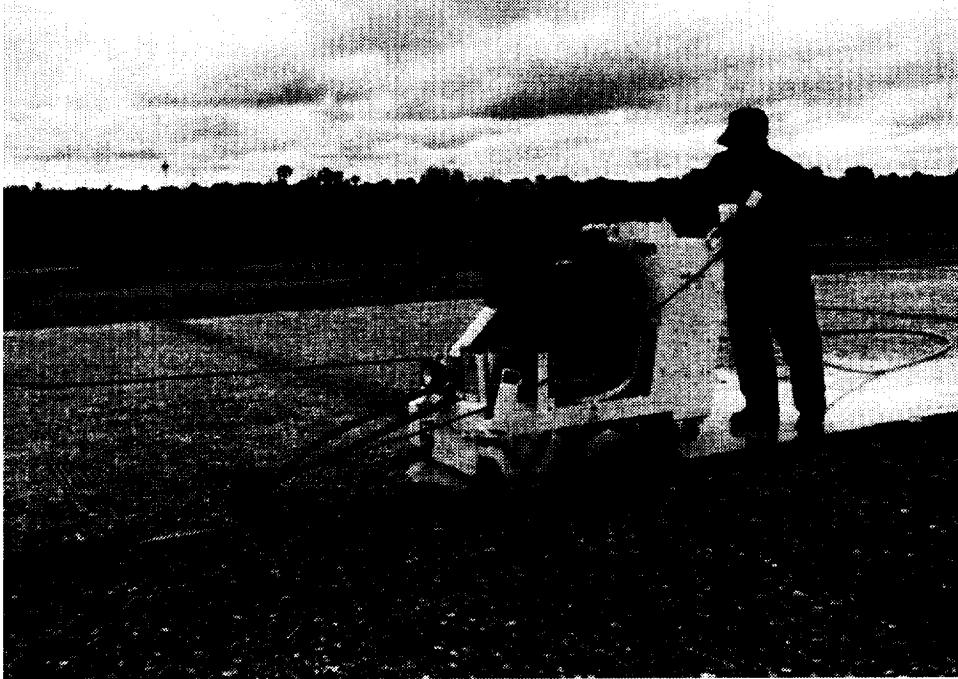
Figure 14. Diamond-blade-grinding machine.

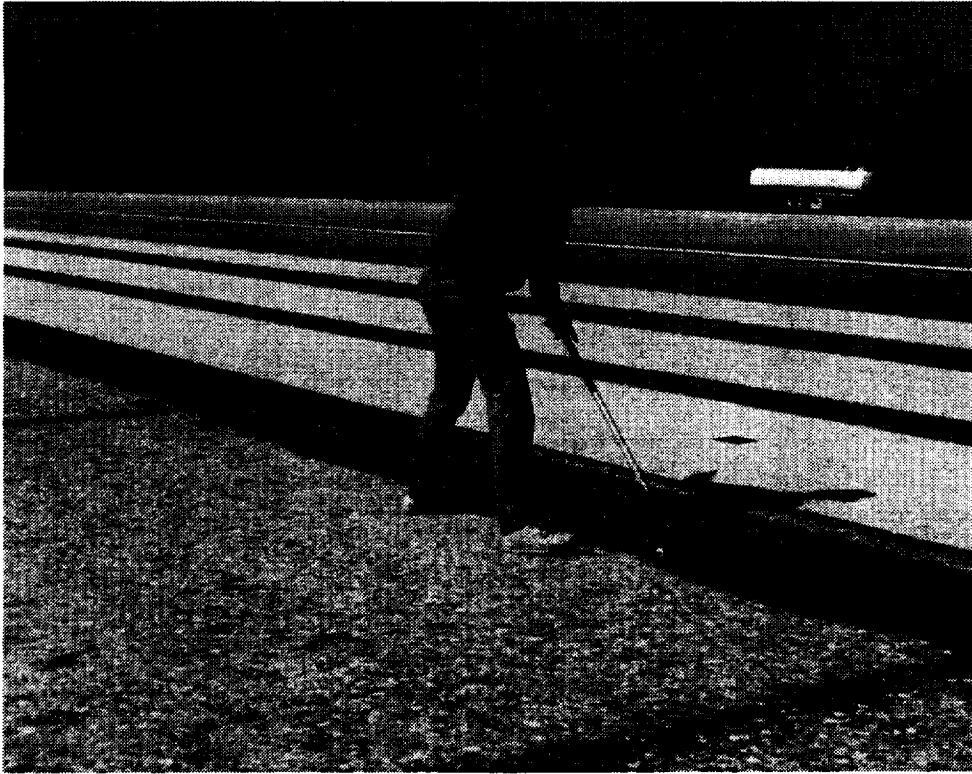
(a) Application to corduroy surface.

(b) Appearance of methacrylate after drying on surface.

Figure 20. Methacrylate coating.
